# CASUALTY REPORT

## The Foundering of KARIN CAT 18 February 2003

DIVISION FOR INVESTIGATION OF  
MARITIME ACCIDENTS

**DANISH MARITIME AUTHORITY**

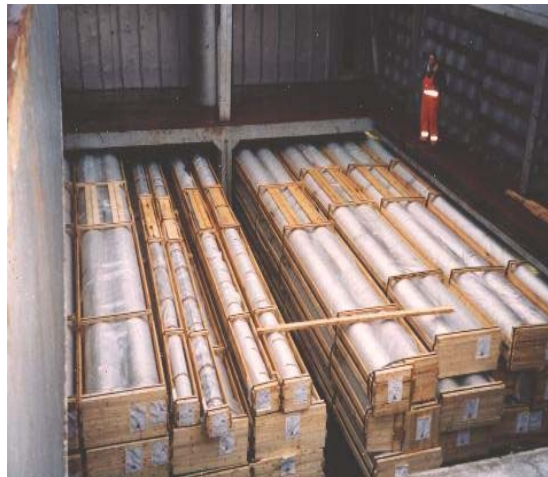
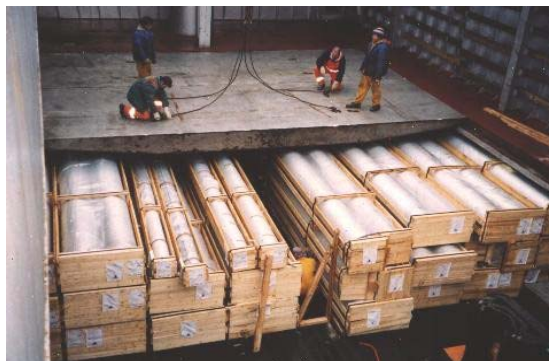
At 0906 a total of 26 crates of pipes were loaded into the lower hold fore part of hatch No. 2. The crates were loaded 3 crates high. The tween deck covers in the fore part were closed and the aft part of the tween deck was opened.

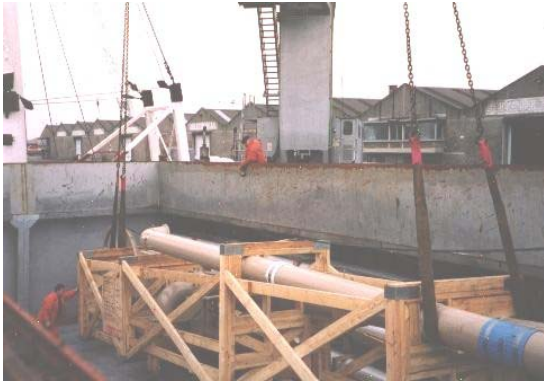
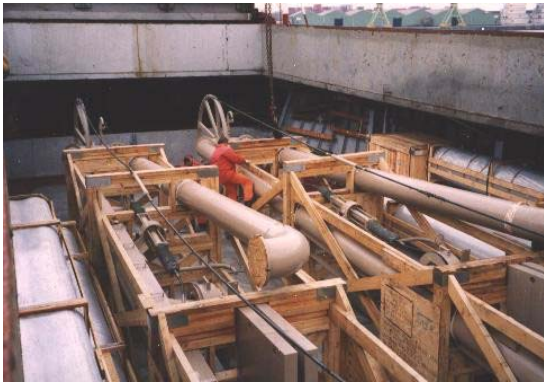
After lunch break, at 1230, the 2 long marine loading arms were loaded into the tween deck No. 1 aft part, one of them at the port side close to the already loaded pipes, the second one close to the already loaded pipes at the starboard side.

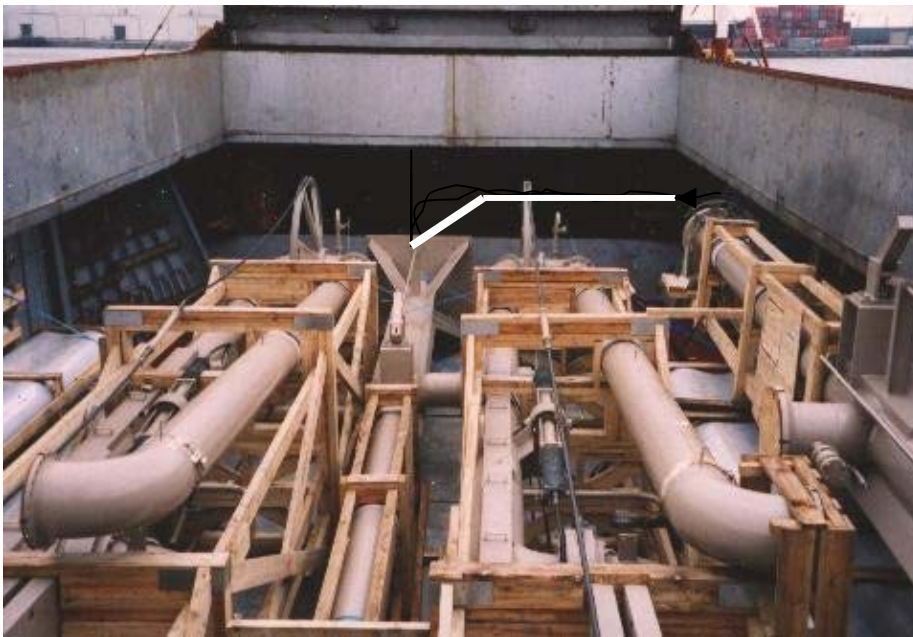
In the morning of 18 February the chief officer and afterwards the master saw that the cargo at the tween deck of hold No. 1 had shifted to starboard. They also saw that the foundation plate of one of the loading arms (in the report of the German surveyor described as base riser) had punched a hole in the side plating of the vessel.

Based on the statements mentioned above the Investigation Division is of the opinion, that a total shift of the cargo in hold No.1, tween deck, had occurred and that it had caused the hole in the hull. The Investigation Division also assumes, that initially the rest of the cargo was still secure and in its stowed position.

An explanation of the cargo shift can only be speculative. The movements of the vessel in the heavy swell could have caused the wooden frames of the loading arms and the wooden stays to collapse with the consequences of slackening and breaking of the lashes followed by the shift of the loading arms.

The foundering of KARIN CAT was caused by a shift of the cargo on the tween deck of hold No.1 whereby a hole was punched in the ship's plating through which seawater poured into the ship at a rate which could not be controlled by the ship's pumps.
